**Quality Audit Response Document**  
**Proposed Residential Development**  
**31 & 31A Raven's Rock Road,**  
**Sandyford Business Park, Dublin 18**

## QUALITY AUDIT RESPONSE DOCUMENT

Quality Audit

<b>Document Ref:</b>	<b>P21-148-UQA-GEN-RP-001</b>
----------------------	-------------------------------

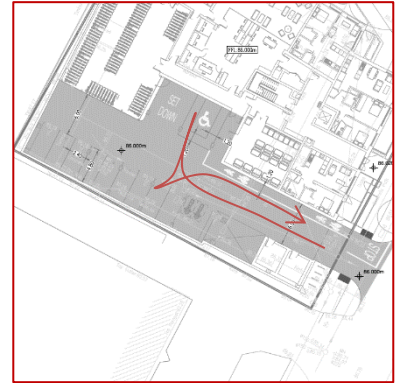
*Summary: It is unclear if emergency, or larger, vehicles will be able to access the development's carpark and if they will be able to safely turn around within the carpark extents.*

Columns have been indicated within the development's carpark which suggest that it is covered, or at least partially covered. It is unclear what clearance will be provided to the soffit and if drivers, particularly those in high sided vehicles (e.g. vans, ambulances etc.), will be warned of the height restriction on approach. If sufficient warning is not provided there is a risk of strikes and material damage.

Additionally, information regarding swept path analysis within the carpark has not been provided and it is therefore unclear if a van or ambulance will be able to safely turn within the carpark.

Signage shall be erected at the entrance to the car park, warning drivers of height restrictions. Sufficient space has been provided within the development car parking area to accommodate the turning manoeuvres of ambulances and other servicing vehicles. Please refer to CS Consulting drawing no. **RR-CSC-XX-XX-DR-C-0007** and **RR-CSC-XX-XX-DR-C-0017** for details of swept path within the development car park.

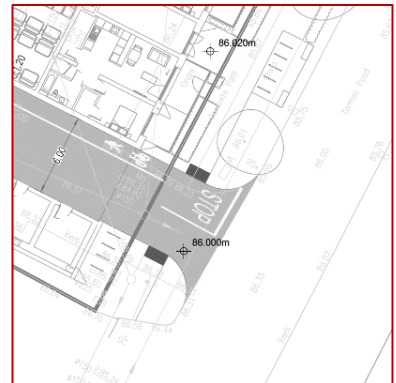
*Summary: A 'Stop' sign has not been indicated at the exit from the proposed development's carpark.*

A 'Stop' sign has not been indicated at the exit from the development's carpark. While 'Stop' text and lining has been indicated on the carriageway there is a risk that this may fade overtime or become obscured during adverse weather.

This could lead to drivers being insufficiently aware of the location of the junction and the need to stop resulting in them failing to come to a stop before entering Ravensrock Road and overshoot type incidents and side-on collisions with vehicles on Ravens Rock Road.

A 'Stop' sign has been provided at the car park exit as shown on CS Consulting drawing no. **RR-CSC-XX-XX-DR-C-0017**.

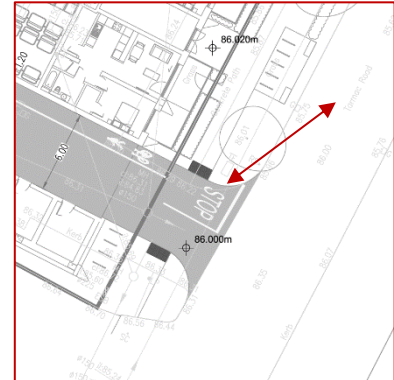
*Summary: Trees indicated on the northern side of the development access may restrict a driver’s visibility when exiting the development onto Ravens Rock Road.*

Trees have been indicated on the northern side of the development access within the visibility splay of drivers exiting the carpark. The clearance to the tree canopy is unclear and, if too low, there is a risk that it may restrict visibility to the north for drivers exiting the carpark. This could lead to drivers exiting the carpark when it is unsafe to do so, increasing the risk of side-on collisions with vehicles on Ravens Rock Road.

Proposed trees shall have a narrow trunk and shall not restrict visibility from the development car park exit. Refer to CS Consulting drawing no. **RR-CSC-XX-XX-DR-C-0006** and **RR-CSC-XX-XX-DR-C-0017**.

Ensure the proposed trees do not restrict an exiting driver’s visibility to the north when exiting the proposed development.

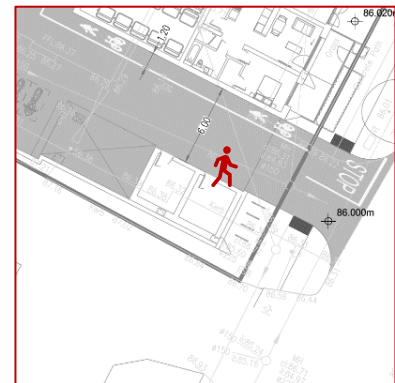
*Summary: The location of the doors to the buildings within the carpark adjacent the development’s access will result in pedestrians exiting directly into the carpark carriageway and possibly into the path of a vehicle entering the development.*

Two buildings/rooms are indicated within the proposed development’s carpark adjacent the access. The doors are indicated such that pedestrians will exit these rooms/buildings directly into the carriageway. Drivers entering the development may have insufficient visibility towards this location and may therefore not anticipate a pedestrian exiting these rooms into their path, resulting in an increased risk of vehicle-pedestrian collisions.

Doors within the two rooms adjacent to the car park access have been revised to open from a different location within the room and shall now open onto pedestrian only areas. Refer to CS Consulting drawing no. **RR-CSC-XX-XX-DR-C-0017** for details.

The doors should open into a pedestrian area, away from motorised traffic.

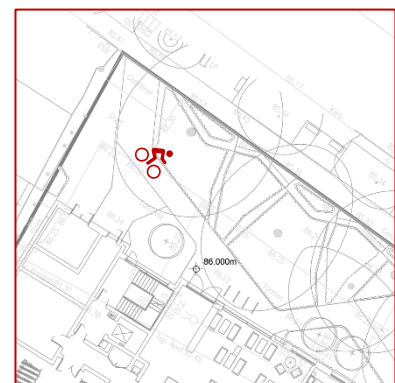
*Summary: Low hanging tree canopies may obstruct vulnerable road users (VRUs) along pedestrian/cycle routes.*

Trees have been indicated within the landscaped area adjacent to the development’s northern boundary. It is however unclear at what height the tree canopy will be mounted relative to the footpath at this location. If there is insufficient clearance beneath the tree canopy, there is a risk that tree branches may present a hazard to VRUs resulting in personal injuries if struck.

Also, during Autumn months, fallen leaves may accumulate within the pedestrian/cycle routes increasing the risk of skidding for cyclists, or slips and falls for pedestrians.

Existing tree canopies provide sufficient vertical clearance for cyclists and pedestrians. Additionally, the management company shall be responsible for the upkeep of areas within the site, including removal of fallen leaves to keep paths clear for VRU's. Refer to CS Consulting drawing no. **RR-CSC-XX-XX-DR-C-0017** for details.

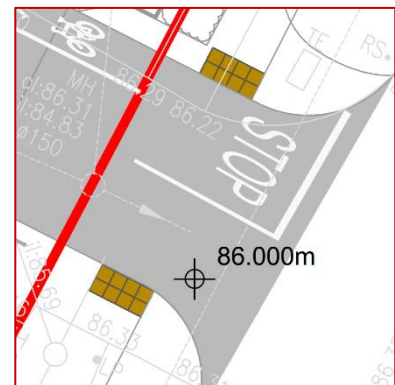
An uncontrolled pedestrian crossing has been indicated across the access to the proposed development. The tactile paving on both sides of the crossing is indicated as only two rows of tactile paving deep which is not the required depth for an inline crossing.

This may lead to visually impaired pedestrians stepping over the tactile paving and inadvertently entering the carriageway where there is an increased risk of being struck by a vehicle.

3no. rows of tactile paving have been provided at the pedestrian crossing of the development access junction. Please refer to CS Consulting drawing no. **RR-CSC-XX-XX-DR-C-0005**, **RR-CSC-XX-XX-DR-C-0006**, and **RR-CSC-XX-XX-DR-C-0017** for details.

The tactile paving at inline pedestrian crossings should be a minimum of 1.2m (three rows of tactile) deep.

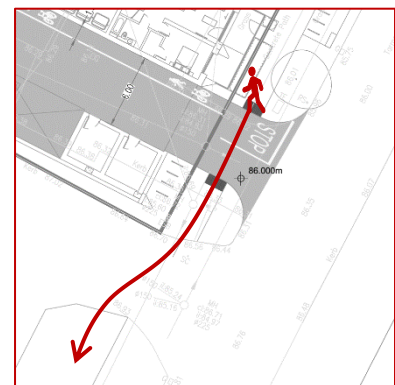
During the site visit, the Audit Team noted that the existing footpath on the southern side of the proposed development access does not align with the footpath further south on the opposite side of the adjacent access. It is unclear from the drawing provided if the proposed amendments at the existing access junction will rectify this problem.

If the footpath on the southern side of the adjacent access does not align with the footpath on the southern side of the development access a visually impaired pedestrian may be directed away from the downstream footpath and into a grassed verge, where they may trip on a high kerb, or into a carpark increasing the risk of being struck by a vehicle.

The development access junction has been designed such that the footpath on the southern side of the proposed development aligns with the footpath further south. Please refer to CS Consulting drawing no. **RR-CSC-XX-XX-DR-C-0017** for details.

Ensure the footpath on the southern side of the proposed development access aligns with the footpath further south of the adjacent access such that a visually impaired pedestrian is directed to the downstream footpath.

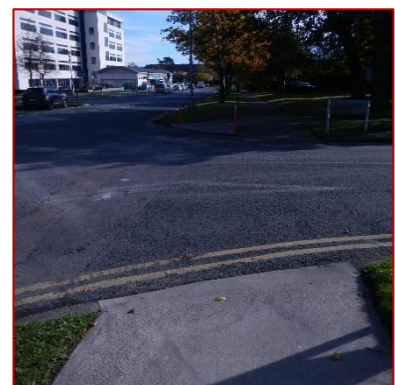
- 3.5.1 There is no tactile paving provided at the existing dropped kerbs on both sides of the pedestrian crossing of the Ravens Rock Road at its junction with the Carmanhall Road adjacent to the proposed development. The lack of tactile paving at the crossing may lead to visually impaired pedestrians inadvertently entering the carriageway where they are at an increased risk of being struck by a vehicle. Whilst the Audit Team acknowledge that this is outside the scope of the proposed development, this issue should be brought to the attention of the Local Authority.

The absence of tactile paving at the existing dropped kerbs on both sides of the pedestrian junction of the Ravens Rock Road at its junction with Carmanhall Road is noted.

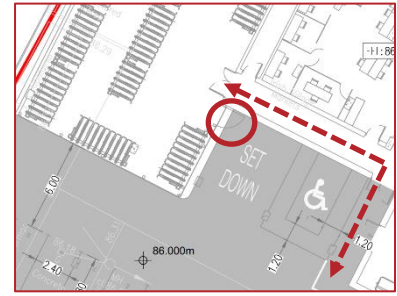
### 5.2.2 Issue

An access to the internal cycle parking facilities from the development's carpark have been indicated to the rear of the proposed Set Down area. Cyclists may be unable to access the cycle parking facilities from this location when the Set Down area is occupied.

Access to the proposed internal cycle parking facilities is proposed from other routes within the development. If this access is not required, it should be removed.

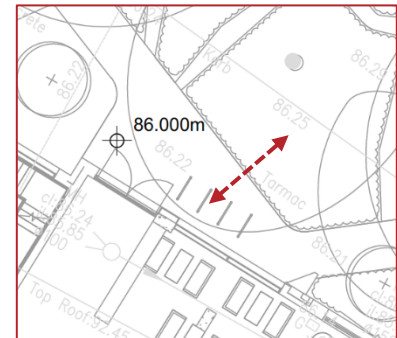
### 5.2.4 Issue

Cycle parking stands have been indicated adjacent the access to the apartment block in the landscaped area at the development's northern boundary. When occupied, bicycles may encroach into the adjacent footway reducing its effective width for pedestrians and cyclists and preventing access to the apartment block.

Relocate these bicycle parking stands to the adjacent grassed verge where an area of hard standing should be provided to house the stands.
