Arboricultural Report

Tree Survey,
Arboricultural Impact Assessment &
Arboricultural Method Statement

31 & 31a Ravens Rock Road
Sandyford Business Park
Dublin

March 2022

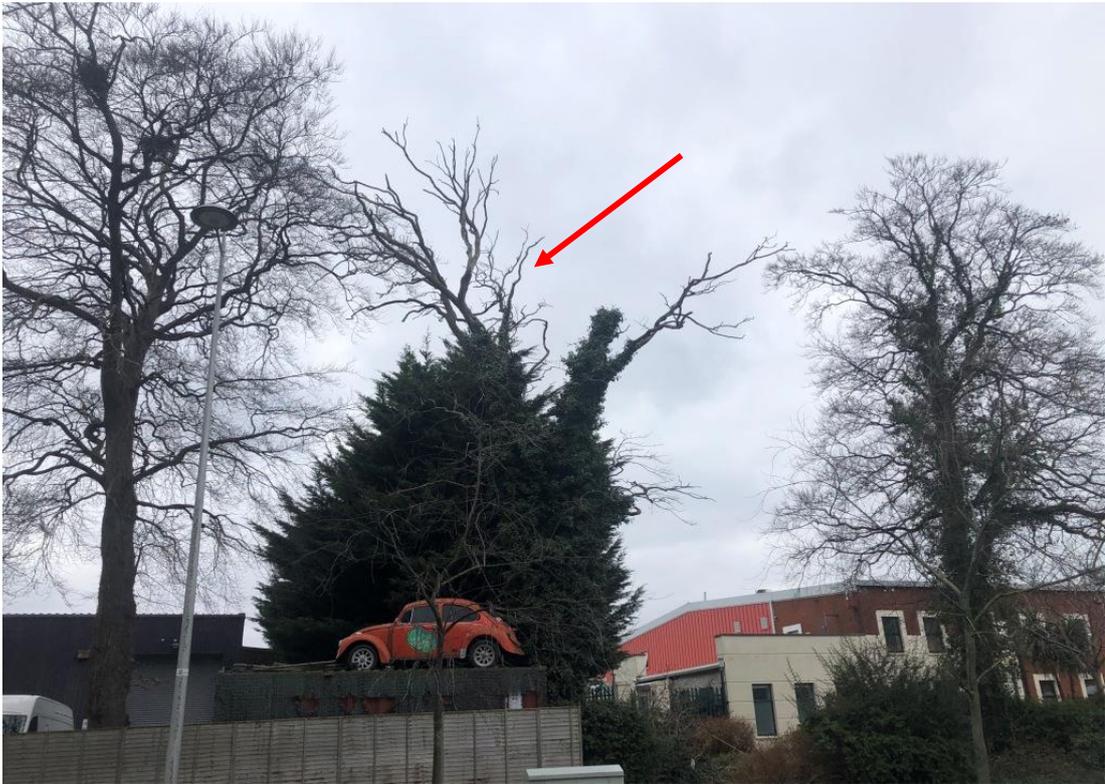
Photo 1: View of the dead beech tree (T14) from Carmanhall Road.

- 1.4 The proposal will require the removal of one poor quality Leyland cypress hedgerow and one low quality and value Leyland cypress tree group. It is also required that one dead mature beech tree be removed for health and safety purposes.

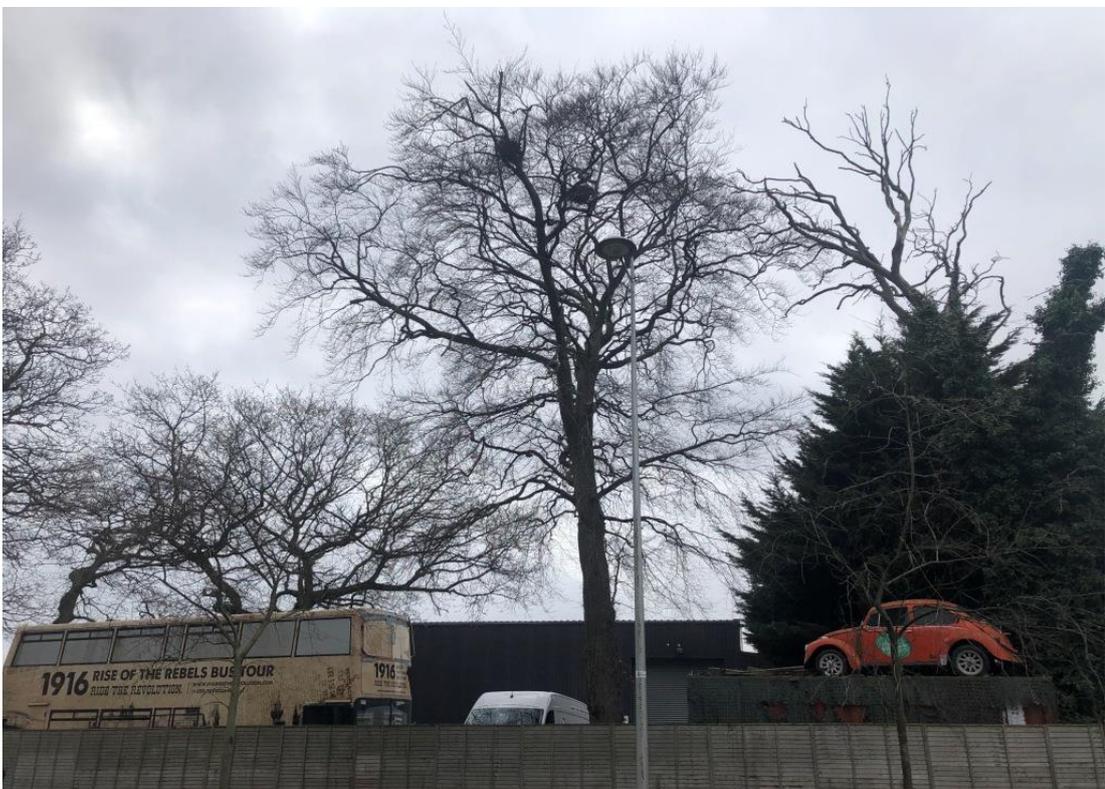
Photo 2: View of C Category beech tree T13 from Carmanhall Road. This tree is showing signs of physiological stress as a result of the compacted rooting environment.

- 6.31 **Impacts on soil hydrology and nutrient availability** – The existing trees (T9 to T13) are growing within a compacted soil environment that will be restricting water infiltration and gaseous exchange. Such harsh growing environments are common within urban areas and can have a negative impact on tree growth and function, which can reduce the useful life expectancy of a tree.

- 6.32 The proposal aims to improve the growing environment of these trees by changing large areas of the rooting environment from hard standing to soft landscaping. Combining this with the proposed decompaction works and the incorporation of soil improvements, water infiltration and nutrient availability will be enhanced. These works have the potential to improve tree health and prolong the useful life expectancy of these trees within the urban environment.

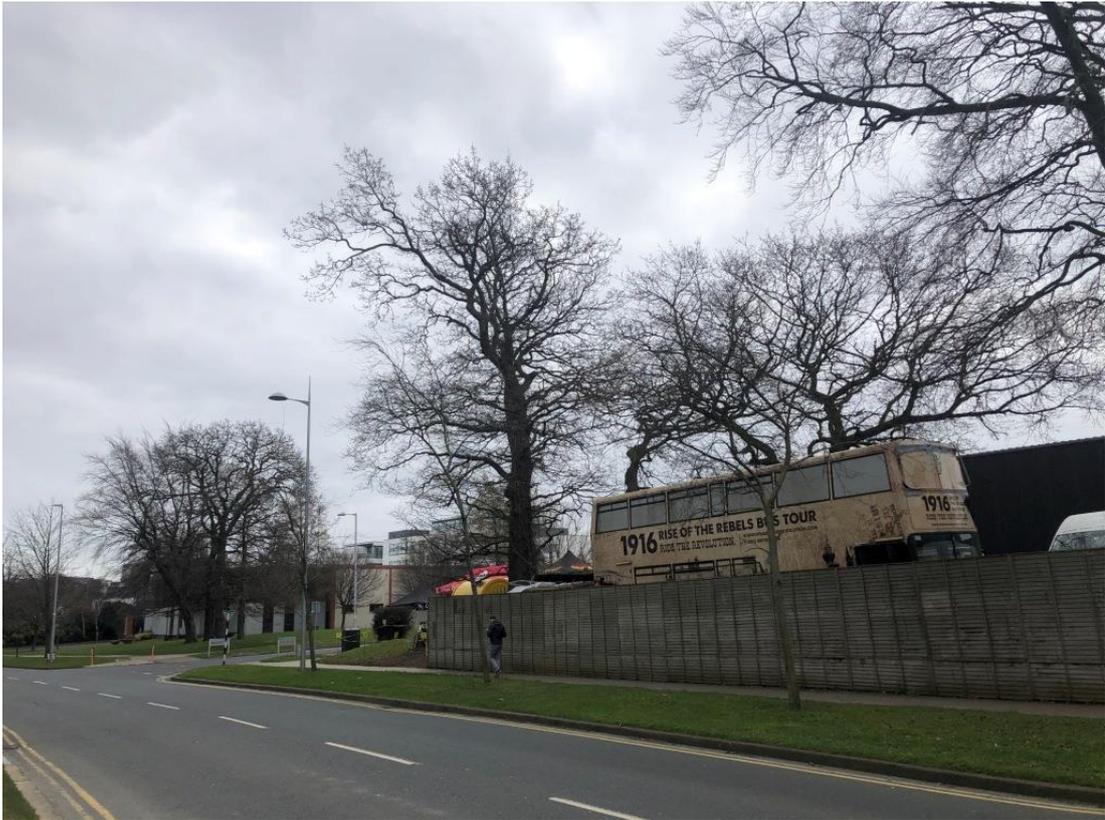
Photo 3: View of oak trees (T9 to T12) and silver maple street trees (T3 to T5) located along Carmanhall Road.

- 6.10 **Demolition of existing hard standing** – There are currently large areas of hard standing within the RPAs of retained trees T9 to T13. The rooting environments of these trees is in poor condition and seriously compacted. As part of the proposed works, the existing hard standing within the tree RPAs is required to be removed.

- 6.11 To minimise the impact on these trees, the removal of hard standing within RPAs will be carried out under arboricultural supervision using a combination of a lightweight track machine and manual tools, depending on the surface to be removed. The main principle during these works will be that no excavation is carried out beyond the depth of the existing sub-base layer. This is likely to vary across the tree rooting areas, so preliminary trial hole investigation works are required to be carried out before the main removal works occur.
