**Quality Audit Response Document**  
**Proposed Residential Development**  
**31 & 31A Raven's Rock Road,**  
**Sandyford Business Park, Dublin 18**

## QUALITY AUDIT RESPONSE DOCUMENT

Quality Audit

<b>Document Ref:</b>	<b>P21-148-UQA-GEN-RP-001</b>
----------------------	-------------------------------

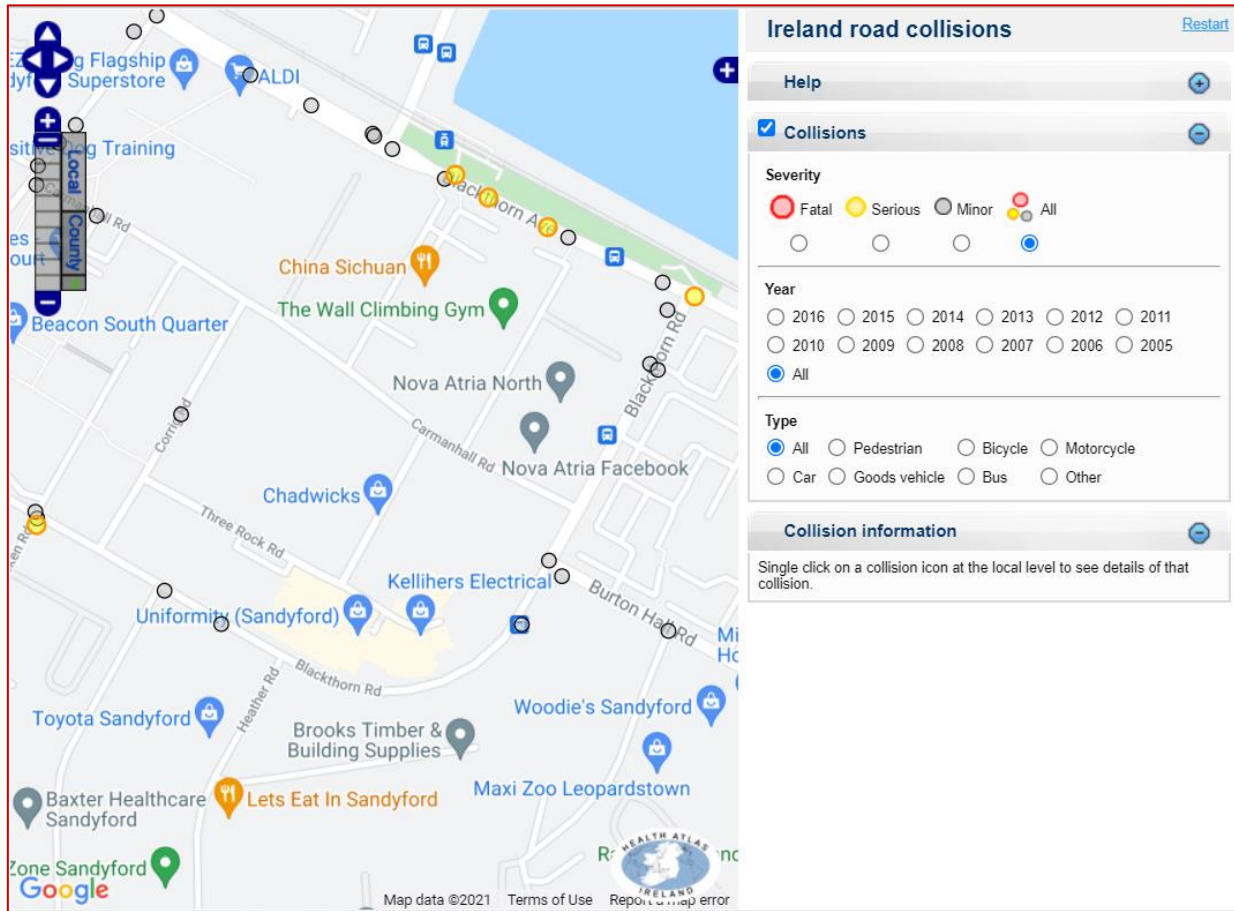
**FIGURE 3.1: COLLISIONS RECORDED ON THE ROAD SAFETY AUTHORITY COLLISION DATABASE IN THE VICINITY OF THE PROPOSED DEVELOPMENT (SOURCE: WWW.RSA.IE)**

No collisions were recorded in the vicinity of the proposed development between 2005 and 2016.

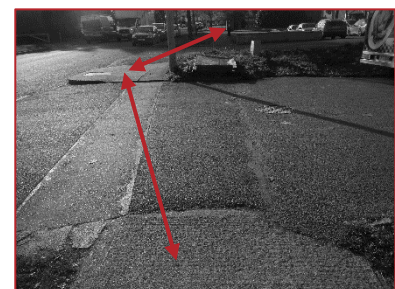
During the site visit, the Audit Team noted that the existing footpath on the southern side of the proposed development access does not align with the footpath further south on the opposite side of the adjacent access. It is unclear from the drawing provided if the proposed amendments at the existing access junction will rectify this problem.

Ensure the footpath on the southern side of the proposed development access aligns with the footpath further south of the adjacent access such that a visually impaired pedestrian is directed to the downstream footpath.
