Arboricultural Report

Tree Survey,
Arboricultural Impact Assessment &
Arboricultural Method Statement

31 & 31a Ravens Rock Road
Sandyford Business Park
Dublin

March 2022

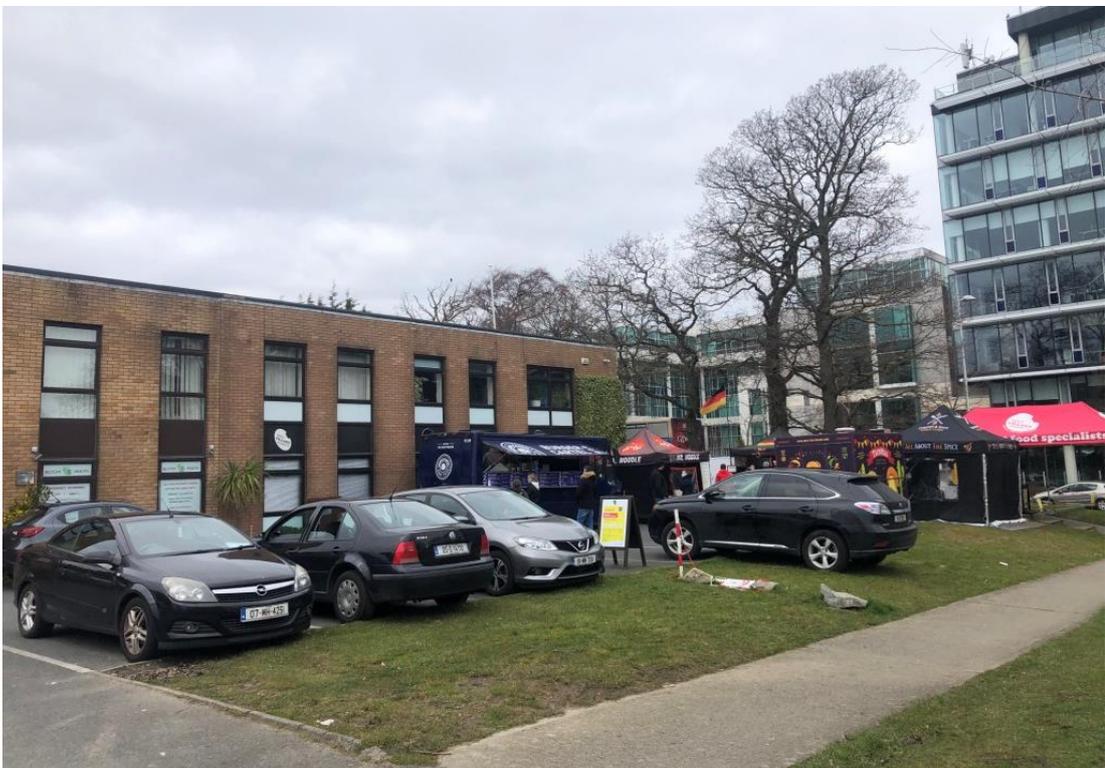
Photo 4: View of the site and existing building from Ravensrock Road.

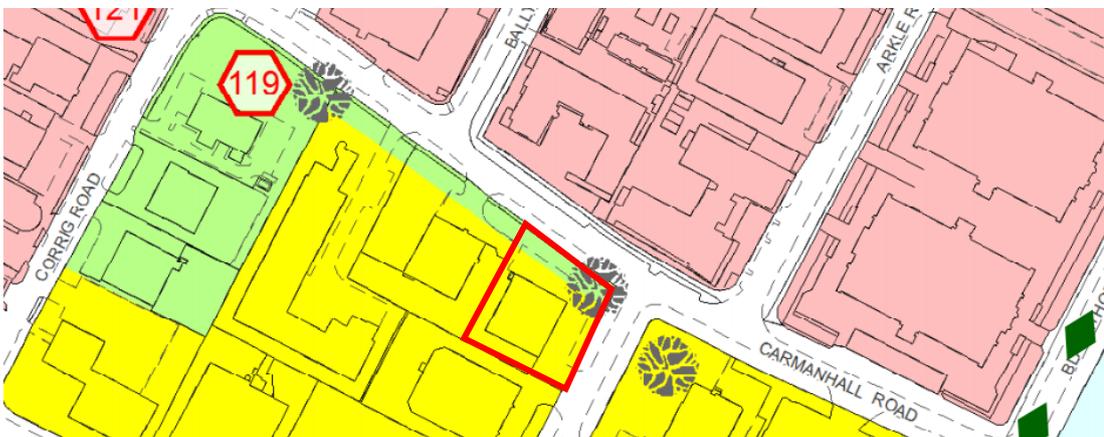
- 4.2 According to Map 6 of the County Development Plan 2016 – 2022, the northern boundary trees have been specifically highlighted to protect and preserve.

Map 2: Extract from Map 6 of the Development Plan 2016-2022 showing the requirement to protect and preserve the northern boundary trees. Red line indicates the main site area.

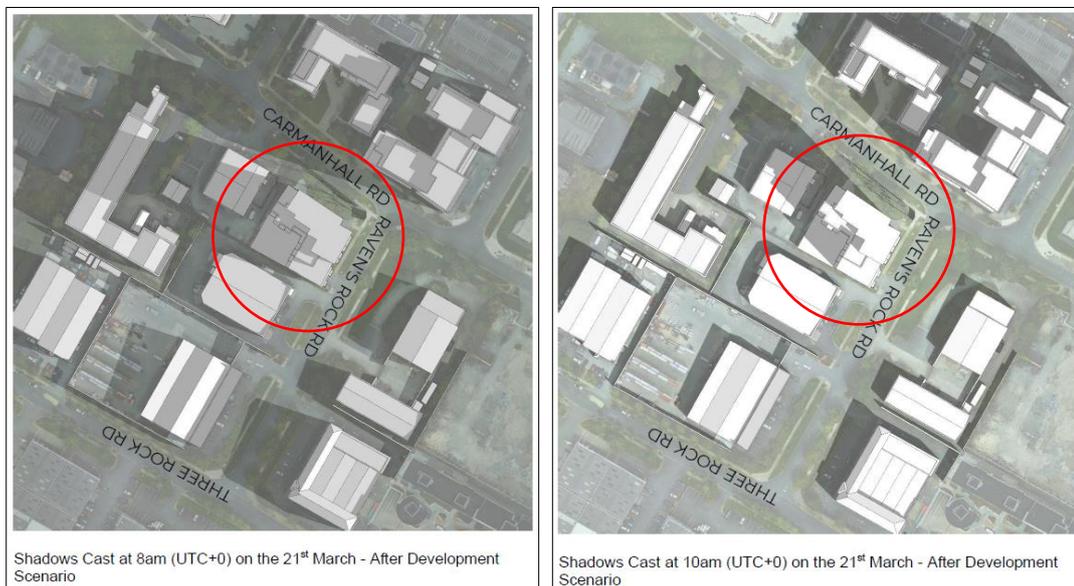
- 6.20 In relation to this proposal, direct sunlight will largely be restricted from the south for the majority of the year. However, on clear days during spring to autumn, the trees will still receive some level of direct sunlight as is shown in Image 1 & 2. They will also receive diffuse light from above and other orientations throughout the year.

Image 1 & 2: Shadow casting images of the proposed building at 8am and 10am on 21st of March taken from the BPG3 Preliminary Assessment of Daylight Levels report. These images show that in March, the trees would still receive direct sunlight on a clear day in the morning. This would continue throughout the summer months. Building highlighted by red circle.
